**SAIB:** CE-10-20

**Date:** March 16, 2010

**SUBJ:** Wing Structure; Wingtip Extensions

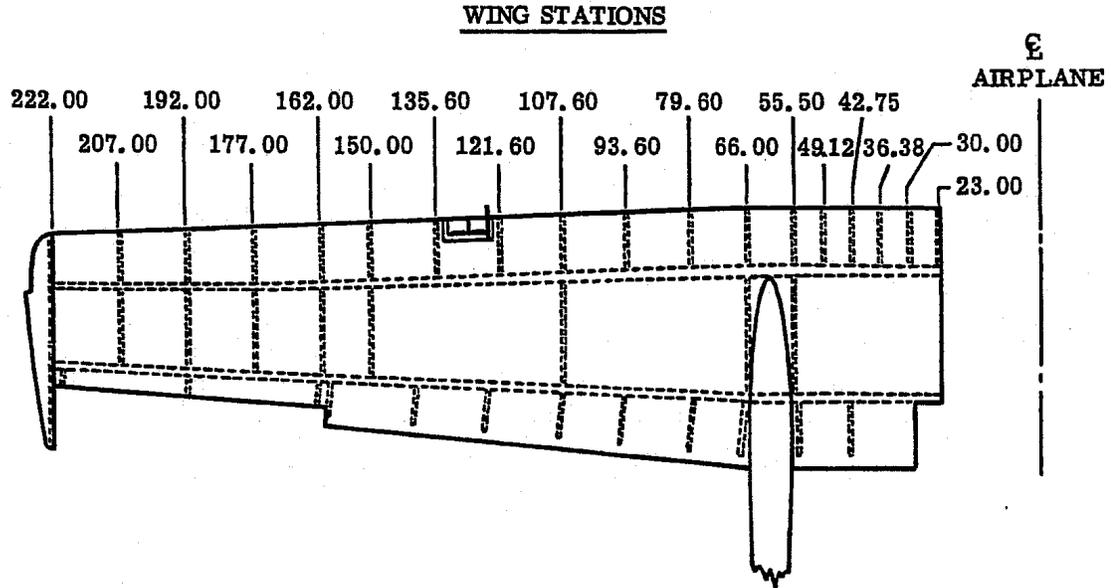
- Wrinkles in upper wing skins;
- Cracking of the upper wing skins. Pay particular attention to any wrinkles, the radius between stiffeners at Wing Station (WSTA) 150 (under fuel tank covers), and unreinforced access holes;

- Smoking rivets at the rib near the inboard aileron hinge (WSTA 162);
- Missing fastener hardware, particularly for attachment of the tips;
- Excessive looseness of attachments of the tip extension to the wing and wing tip to wing extension when pushing up and down on the tip;
- Any signs of distress along both front and rear spars; and
- Unusual repairs to the upper skins, particularly in the area of WSTA 150-162.

1. Review and adhere to all published airspeed and maneuvering limitations for the modified airplane. Look for excessive "bowing" of the tip extensions in flight.
2. Perform a one-time general inspection of the wings for internal and external damage from Wing Station (WSTA) 23 to the wing tip within the next 100 hours time-in-service (TIS). Remove all wing access panels to conduct the inspection. Areas to focus on are listed below. Do this inspection following the appropriate manufacture's service information and any other appropriate guidance, such as FAA Advisory Circular AC 43.13-1B Acceptable Methods, Techniques, and Practices - Aircraft Inspection and Repair.
