## EASA Safety Information Bulletin

**SIB No.:** 2011-27R1  
**Issued:** 05 December 2013

**Subject:** **Suspect (Bogus - Counterfeit) Electronic Components**

**Applicability:** Manufacturing and Maintenance Organisations using Integrated Circuits (ICs) and other electronic components

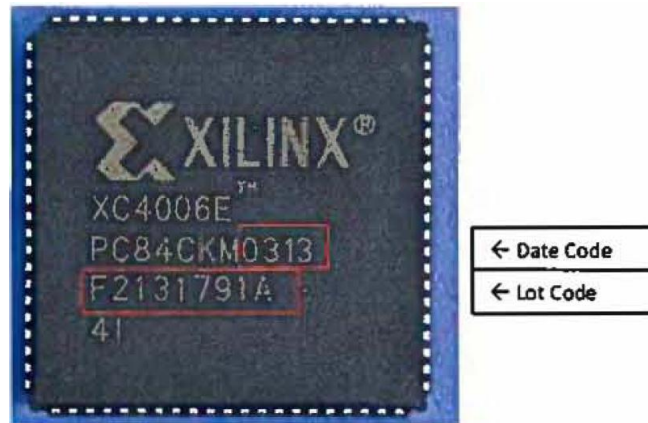
Example

The following deficiencies have been observed during the process leading to the identification of the bogus ICs:

- Solder wetting issues – common for parts stored over long periods
- Co-planarity issues
- Pins shorted together on some of the parts
- Delamination issues leading to housing cracks
- Potential exposure to Electro Static Discharge may result in latent damage.

**Recommendation:** Manufacturers buying parts through brokers or international dealers are strongly recommended to perform a more extensive incoming components inspection and consider implementing advanced parts tracking, based on lot and date code.

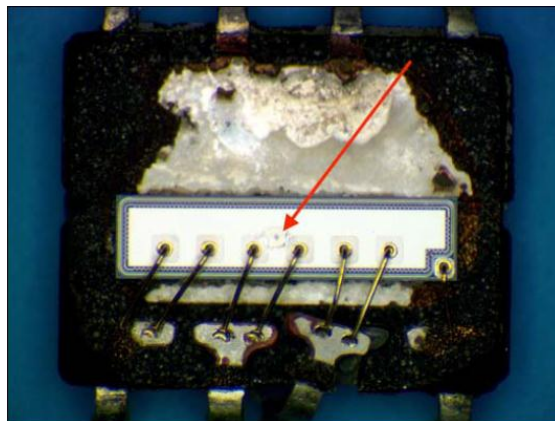
As shown below, a large alloy site was discovered at the centre of die of a sample showing short circuited gate-drain-source.

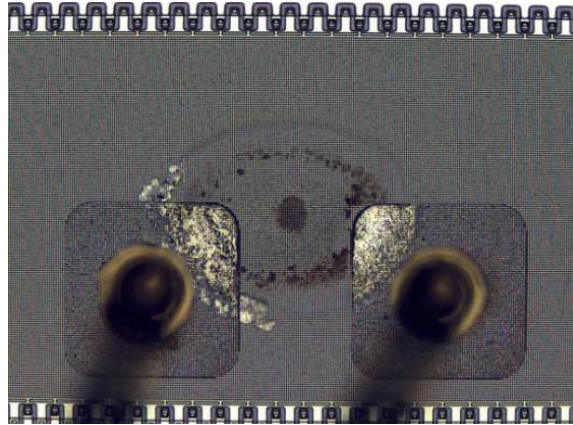
On a second sample, cratering was found beneath the gate bond. Optical and SEM inspection after delayering of both samples revealed cracks in the oxide and cratered silicon beneath the source bonds in each sample. There was also evidence of gold alloying into the source contacts in the damaged areas (see picture below).

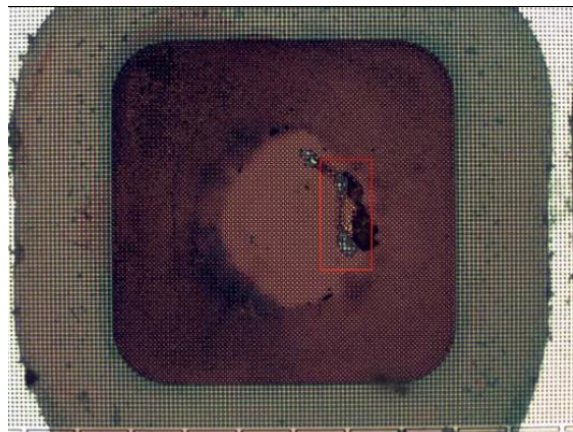
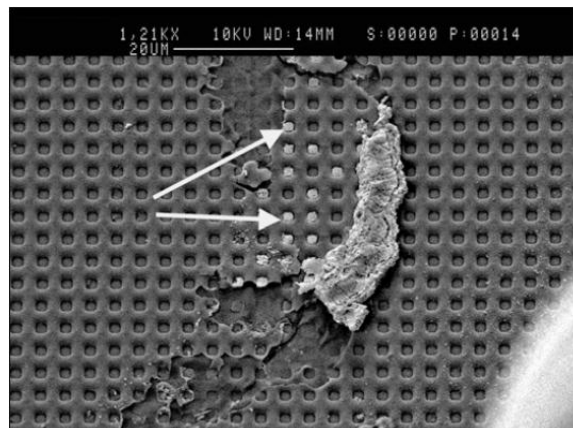
These components induced equipment failures during qualification testing in extreme conditions.

However, given the type of defects, the counterfeit component could result in failures in normal operating conditions.

Additionally, when observing an increase in the failure rate of a board or unexpected equipment failure during qualification or screening tests traced to a component, consider counterfeit components as one potential reason. Implement continuous monitoring of the failure rate to determine if the failure rate is increasing above a level which would invalidate MTBF or safety calculations. In such case, the following actions are recommended:
